STOP EXCESSIVE COOLANT CONSUMPTION OR LEAKAGE!!!!

20574
Engine Manifold
Repair Kit

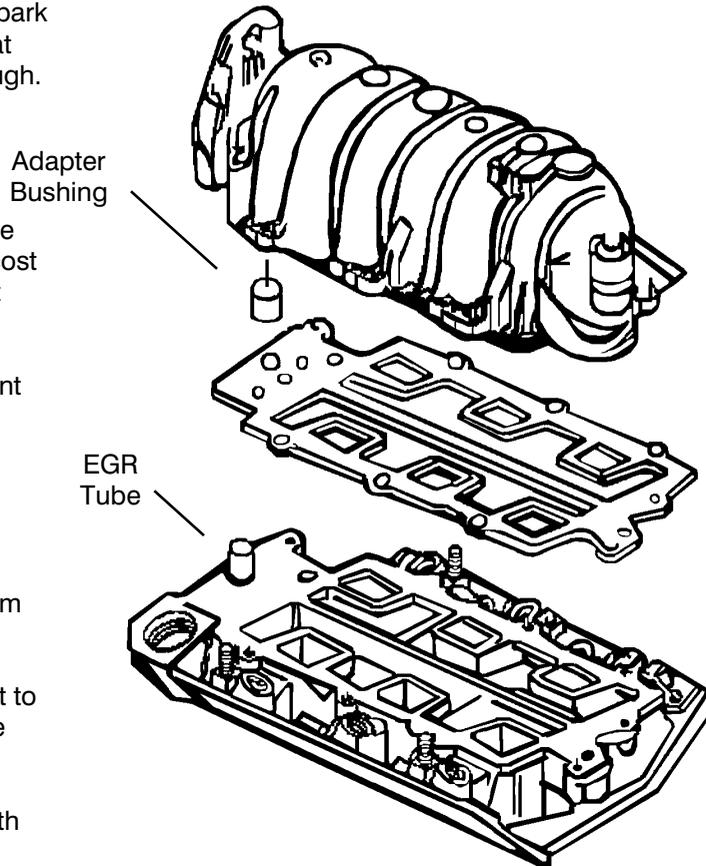
2003 - 1995 GM vehicles with 3.8 L series 2 engines (VIN K - RPO L36) have been experiencing excessive coolant consumption or coolant leakage near or under the throttle body and intake manifold. This is caused when the EGR tube on the lower manifold degrades the composite material of the upper intake plenum around the passage area between the two part manifold. Once the composite material is degraded, it becomes porous and allows the coolant areas on either side of the EGR passage to leak coolant either internally or externally. If it leaks internally into the intake manifold and then the cylinders, it can result in "hydro-lock" of the engine. A simple coolant leak has resulted in a major problem that as best requires changing the spark plugs and oil in order to start the engine. That doesn't correct the cause of the problem though.

As an added benefit, the smaller diameter of our EGR port tube creates an air space between the repaired (with adapter bushing) upper plenum and the new EGR port tube. This air space insulates the composite material of the plenum from further damage.

1. Remove the upper intake manifold.
2. Remove the EGR tube from the bottom plenum.
3. Install our new EGR port tube.
4. Use epoxy supplied with our repair kit to install our new adapter bushing in the upper plenum.
5. Reinstall the upper intake manifold.
(Detailed instructions are included with the kit)
