STOP EXCESSIVE COOLANT CONSUMPTION OR LEAKAGE!!!!

20574
Engine Manifold
Repair Kit

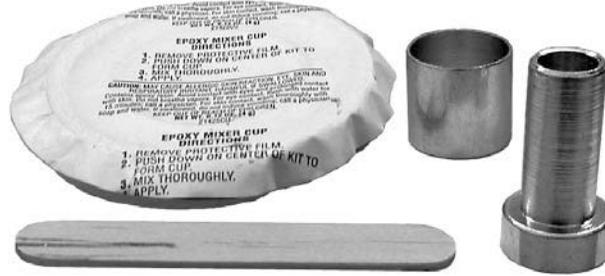
2003 - 1995 GM vehicles with 3.8 L series 2 engines (VIN K - RPO L36) have been experiencing excessive coolant consumption or coolant leakage near or under the throttle body and intake manifold. This is caused when the EGR tube on the lower manifold degrades the composite material of the upper intake plenum around the passage area between the two part manifold. Once the composite material is degraded, it becomes porous and allows the coolant areas on either side of the EGR passage to leak coolant either internally or externally. If it leaks internally into the intake manifold and then the cylinders, it can result in "hydro-lock" of the engine. A simple coolant leak has resulted in a major problem that as best requires changing the spark plugs and oil in order to start the engine. That doesn't correct the cause of the problem though.

Until now, the solution has been to replace the upper plenum and lower manifold at a retail cost of \$1200 - \$1400 for parts and labor. Yet that alone does not correct the root cause of the problem. Our **20574 repair kit** offers an inexpensive but highly effective and permanent solution. Here are the steps involved:

1. Remove the upper intake manifold.
2. Remove the EGR tube from the bottom plenum.
3. Install our new EGR port tube.
4. Use epoxy supplied with our repair kit to install our new adapter bushing in the upper plenum.
5. Reinstall the upper intake manifold.
(Detailed instructions are included with the kit)
